Technical Report ARWSB-TR-09012

Variant M4 Barrel Characterization

15 July 2009

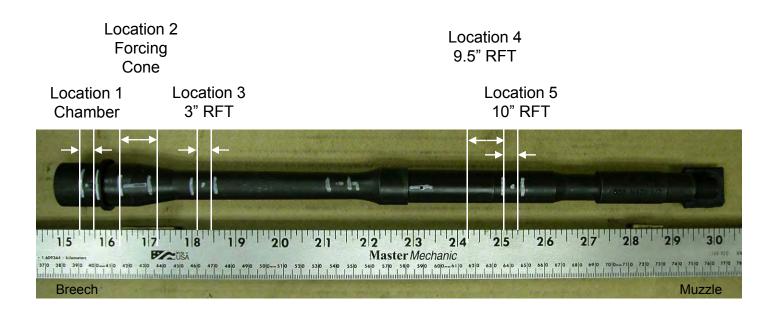
Figure 1: M4 Barrel Cut Plan

The barrels were sectioned to facilitate analysis. Five sections were identified (see Figure 1) mirroring the locations used previously¹⁻³. These locations for analysis are:

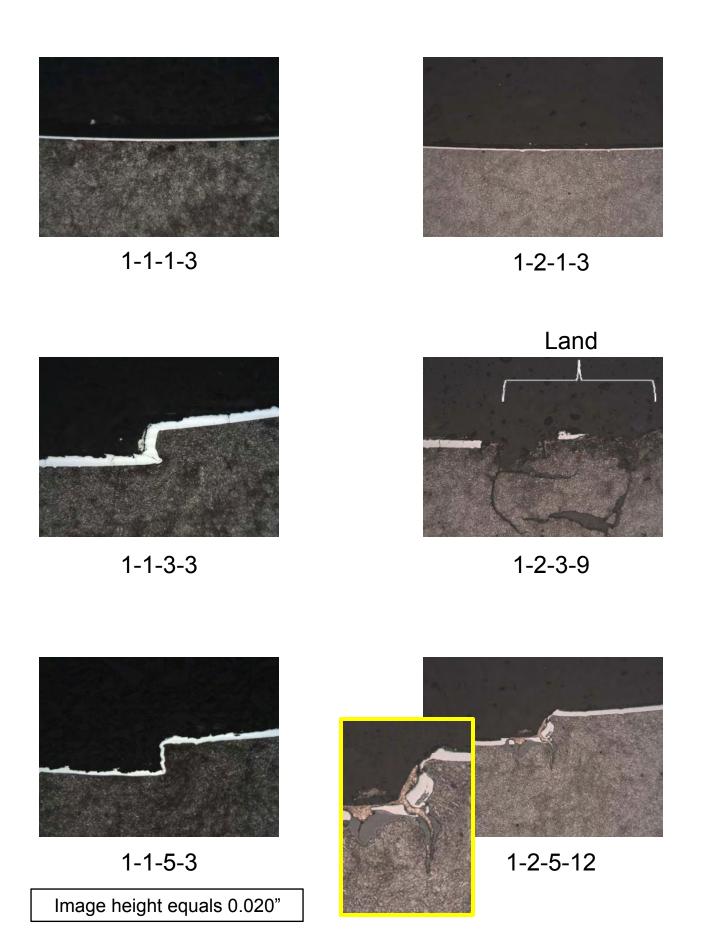
Figure 2: As-received and Fired Configuration 1 Cross-sections

The microstructure of the two steels was indistinguishable. All fired barrels showed a tempering in the microstructure, when compared to the as-received steel. This is confirmed in section 4.3 *Microhardness*. Heat affected zones seen in the fired barrels are relatively thin and localized to wide cracks and surfaces where the chromium has been completely removed.

All fired barrels show extensive copper deposits and damage to the rifling lands, and the type of damage appears to be dictated by the rifling profile. The Configuration 1 and 4 button broach barrels had large deposits of copper at the root of the lands; in addition to collecting copper and firing debris at surface cracks and disparities. The Configuration 2 and 3 hammer forged barrels have a rougher as-received surface. During firing, the rough surface tended to collect copper and debris in the surface troughs. For all fired barrels, the damage was heavier at Location 3 compared to Location 5.

The Configuration 1 and 4 button broach barrels exhibited a limited amount of cracking in the steel in the as-received barrels. These cracks were relatively shallow and extended into the wall at a 45° angle from the bore surface at the root of the land. During firing, these 45° cracks initiated and extended at each land root, on both the driving and leeward side of the land. The location and orientation of the cracks suggest shear forces on the side of the land are the motivating force for cracking. In some instances, the driving and leeward side cracks of a land eventually linked up, and the land is completely removed.

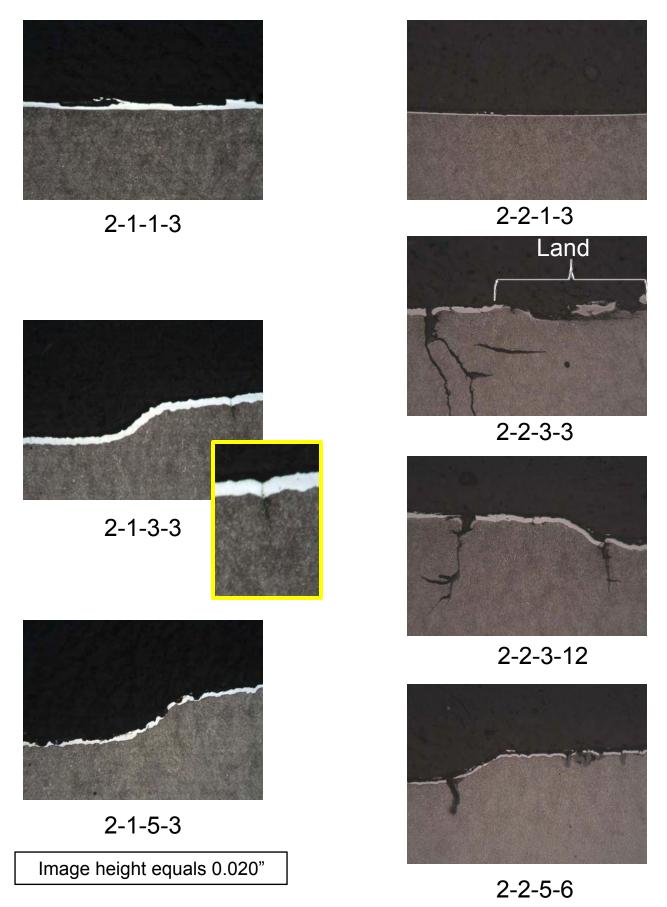
Figure 3: As-received and Fired Configuration 2 Cross-sections

The Configuration 2 and 3 hammer forged barrels showed deeper and more extensive cracking in the asreceived barrels. However, the cracks were oriented perpendicular to the bore surface, and were not associated with a land corner. These cracks tended to occur in the middle of the land or groove surface. During firing, these cracks widened and extended further through the wall. Damage to the land was predominately wear to the driving side land wall. The driving side wall was worn down to a very shallow slope; while the leeward land side was relatively undamaged.

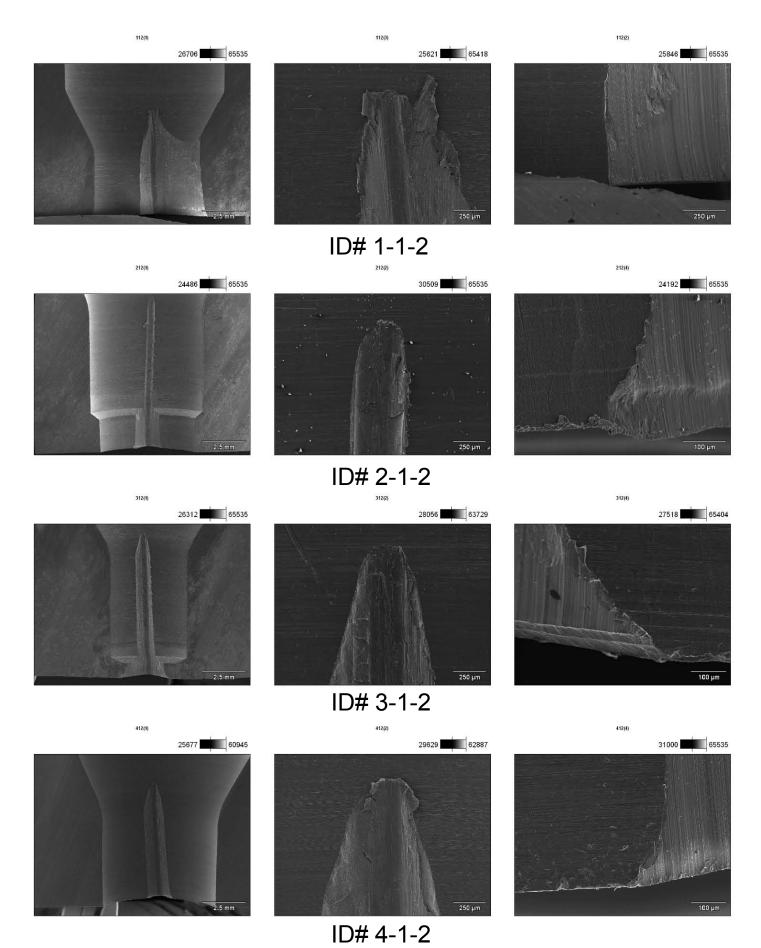
Figure 6: As-Received Forcing Cone Surface and Groove Images

Surface imaging of the as-received Location 2 samples (Figure 6) shows a smooth and complete chromium coating. These samples are also used for coating adhesion testing; see section 4.5 *Adhesion testing* for more information.

The as-received Location 2 samples (Figure 6) were subjected to groove adhesion testing. A tungstencarbide tool bit was scribed through the coating along the axis of the barrel. This groove was then analyzed for adhesive failure adjacent to the groove. No adhesive coating failure was identified.

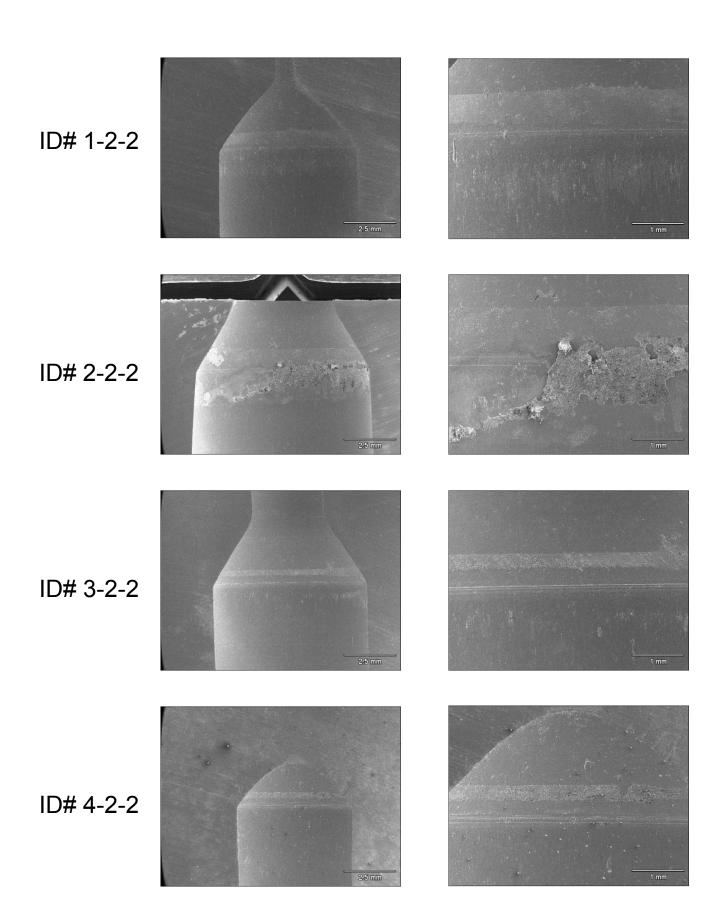
Figure 7: Fired Forcing Cone Surface Images

Surface imaging of the fired Location 2 samples (Figure 7) shows two distinct wear bands in each of the barrel configurations. The first wear band occurs approximately 0.5mm rearward of the chamber/forcing cone junction. This approximate 1mm wide band exhibits extensive mechanical damage to the chromium through numerous axial scratches, dings, and dent. A small percentage of these scratches penetrate the chromium into the steel. The second wear band occurs approximately 0.25mm forward of the chamber/forcing cone junction. This approximate 1mm zone is a contiguous band where the chromium coating has been removed, revealing a belt of steel and corrosion/combustion products. Samples 1-2-2 and 2-2-2 have wider forward wear bands than 3-2-2 and 4-2-2. Sample 2-2-2 was also image with a large amount of combustion products adhered to the chamber/forcing cone junction area. These wear zone issues appear independent of the material and rifling configuration of the barrel.

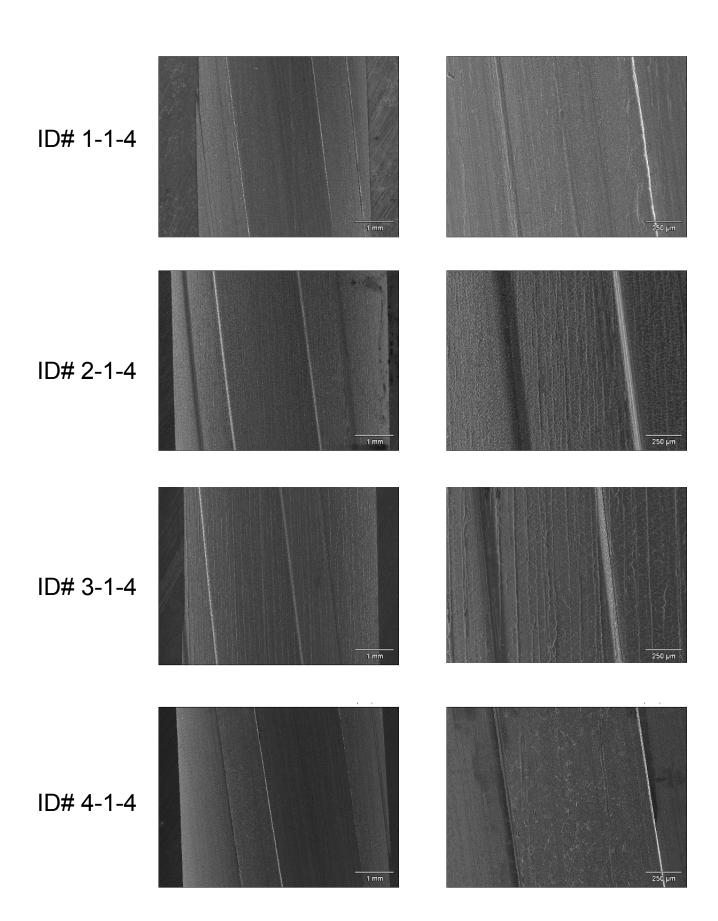
Figure 8: As-Received 9.5" RFT Surface Images

Surface imaging of the as-received Location 4 samples (Figure 8) shows a textured bore surface. Samples 1-1-4 and 4-1-4, the button broached samples, exhibit shallow machining marks on the surface. These marks tend to follow the rifling profile of the bore. Samples 2-1-4 and 3-1-4, the hammer forged samples, exhibit a furrowed surface. Compared with the broached tube surface, these ruts are slightly deeper than the machining marks and align with the tube axis instead the rifling profile.

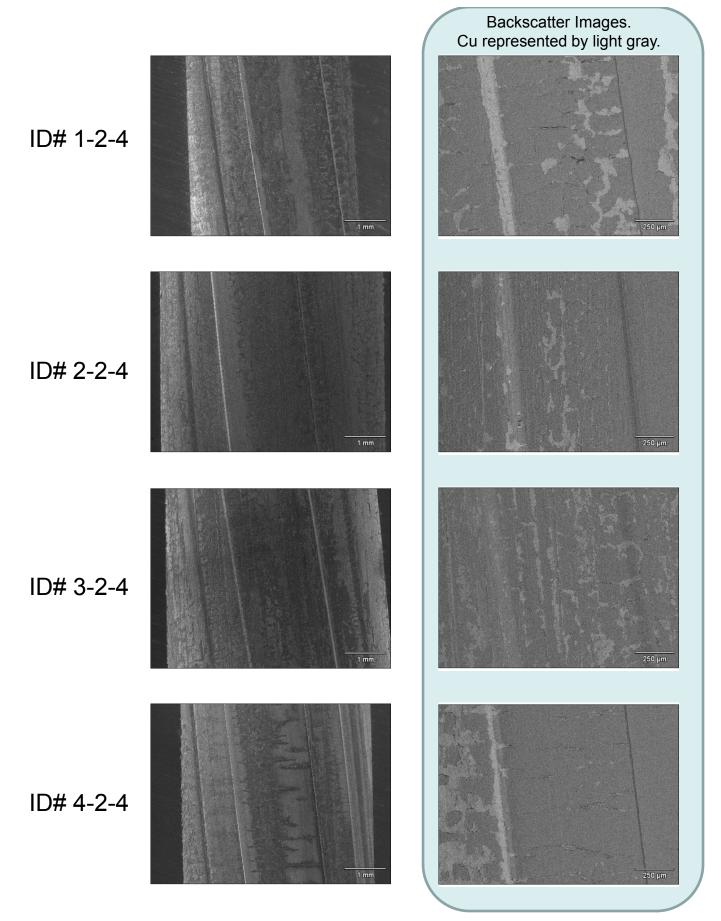
Figure 9: Fired 9.5" RFT Surface Images

Surface imaging of the fired Location 4 samples (Figure 9) shows a cracked and contaminated surface. All the samples exhibit heat check cracking, and these cracks have been subsequently packed with copper and combustion products. The axial surface furrows on the hammer forged samples 2-2-4 and 3-2-4 are also filled with copper. The button broached samples 1-2-4 and 4-2-4 showed a large amount of copper adhered to the root of the driving side land; this driving-side copper build-up is not present in the hammer forged samples.
